Disaster Supplements Meeting

January 25, 2024

Eulando Piñero – Sustainable Workplace Alliance / MERT

Puerto Rico – Typical Mold Problems

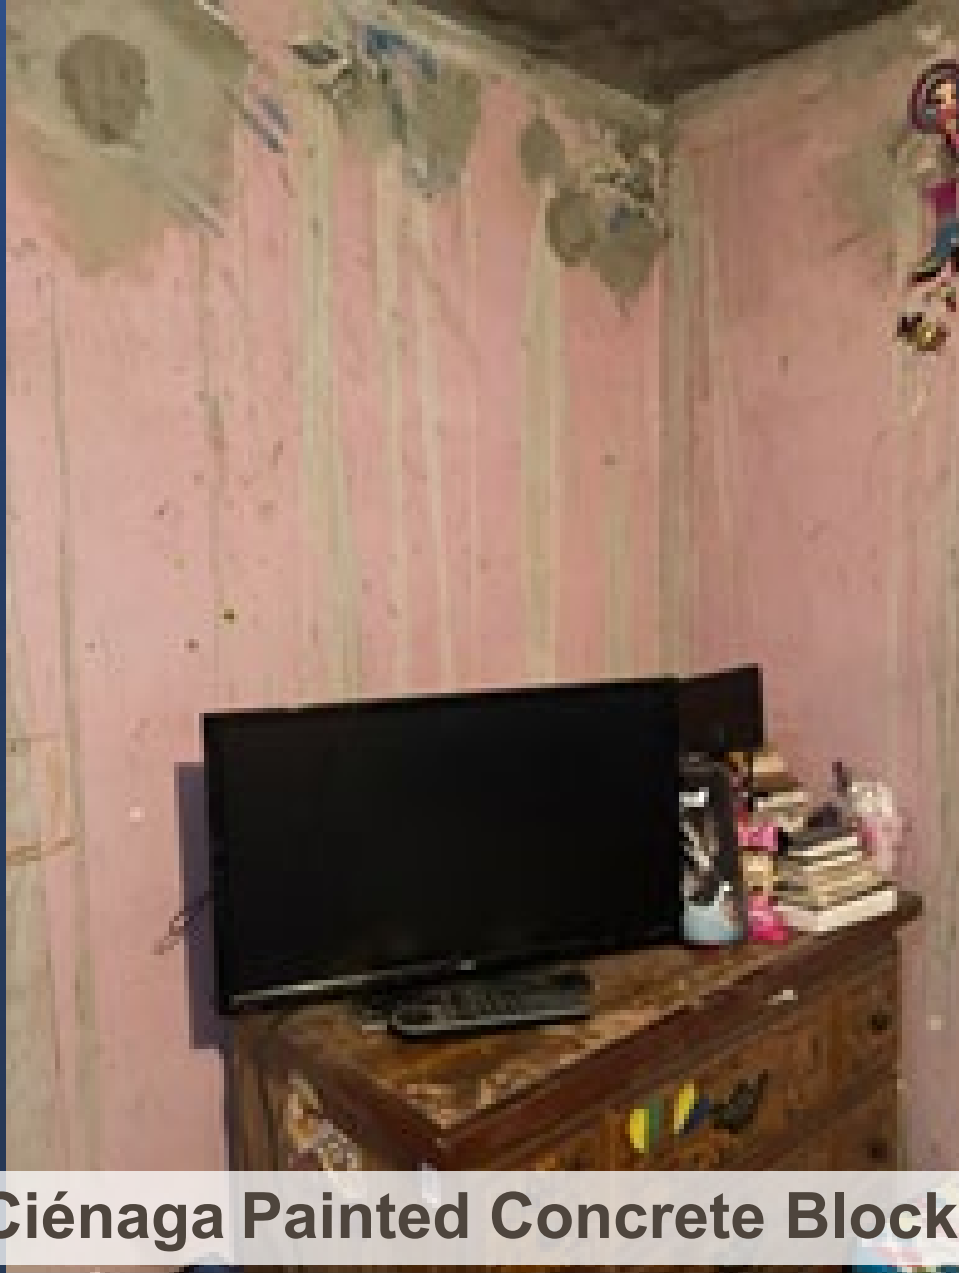
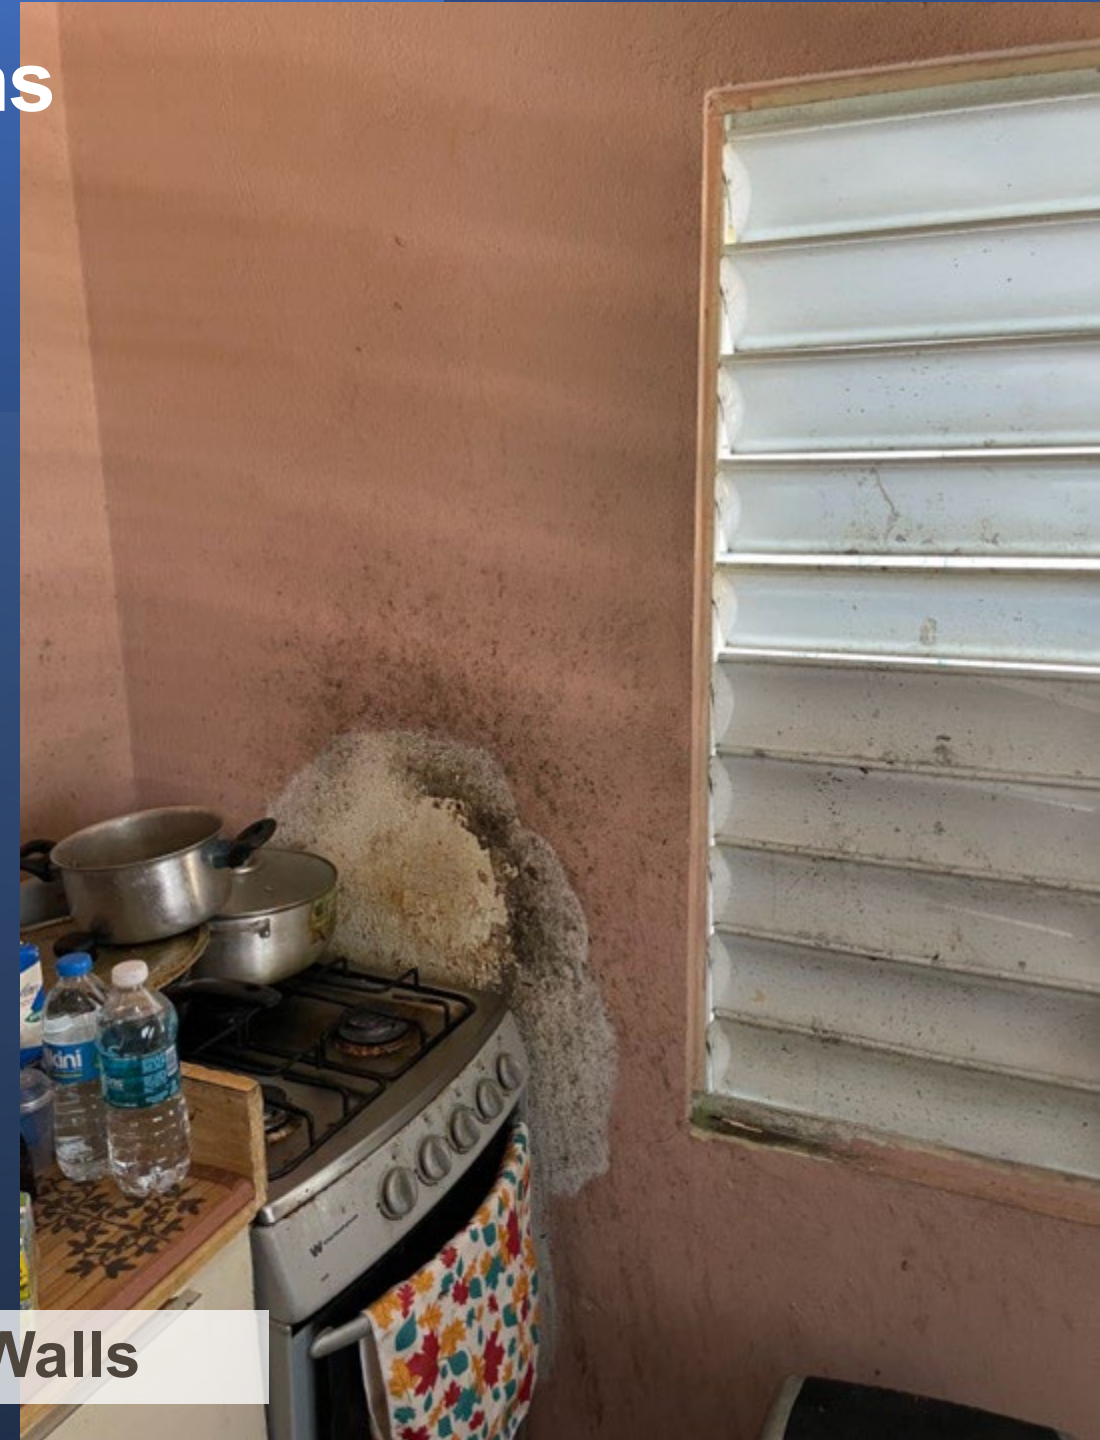
Ciénaga Painted Concrete Block – Interior Walls

Painted Concrete or Metal

Mold growth can and will grow on the painted surfaces of concrete or metal that has been subject to flooding and/or rainwater intrusion through exterior facades or wind-damaged roofs. If mold appears on painted concrete or metal, clean as soon as possible using the following procedure:

- Clean/scrub with dishwashing liquid solution (add borax if available - 1/8 cup dishwashing liquid, 1 cup borax, 1 gallon of water)
- Repaint with mold resistant paint (possible lead-based paint hazard)
- Do not scrape damaged paint

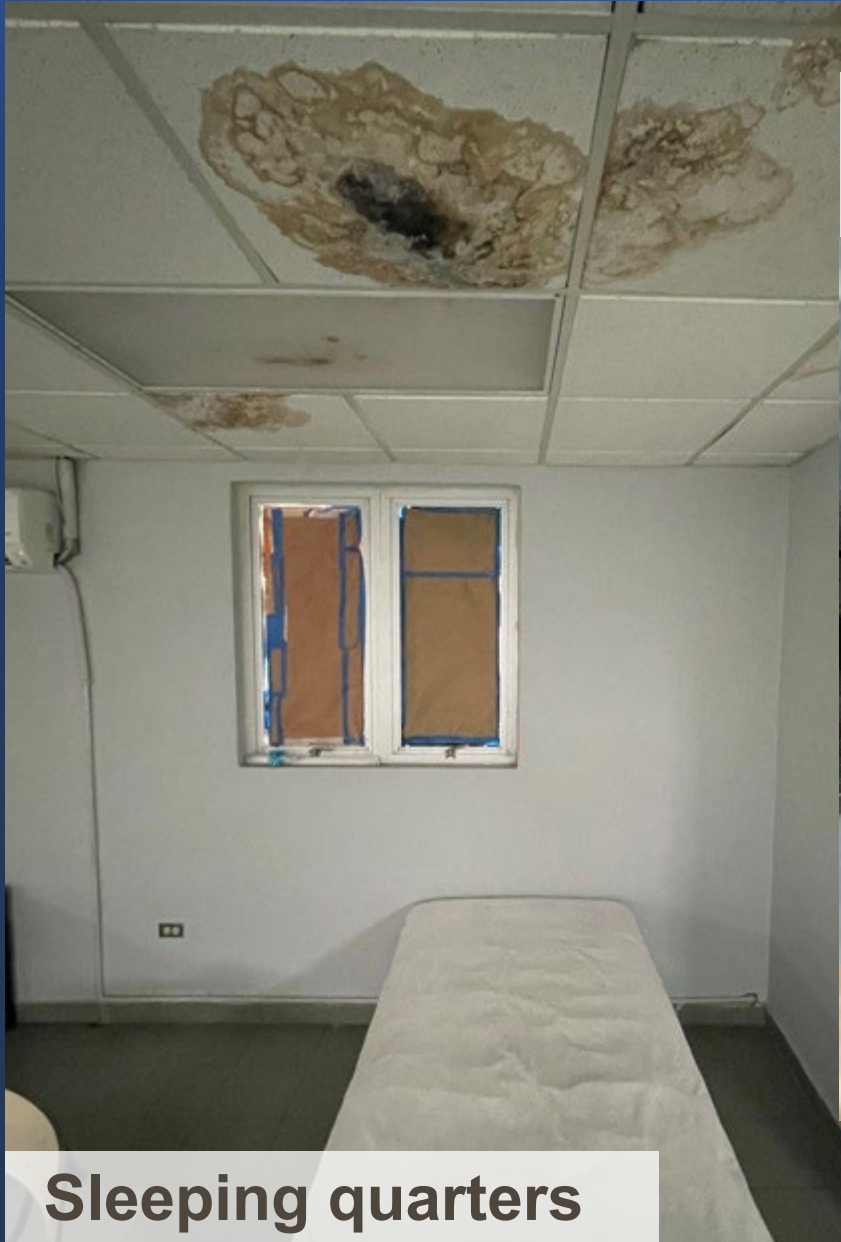
Ponce Fire Station

Sleeping quarters

**Stachybotrys growth
on top side of ceiling**

Water-damaged ceiling tiles generally display a brownish discoloration if the water damage is an isolated event. With recurrent water damage, however, a black center to the brownish discoloration frequently appears. There is a high probability that the black discoloration is *Stachybotrys*, a potentially highly toxic mold, exposure to which (primarily by inhalation) may be associated with severe adverse health effects in humans. Cellulose-containing ceiling tiles are perfect amplification sites for toxigenic fungi. Therefore, the removal of ceiling tiles should be a zero-dust-release procedure and appropriate personal protective equipment (N95 respirator, gloves, and goggles) should be worn to avoid possible acute exposures.
